**DOT/FAA/AR-99/71**

# **Full-Scale Tests of Lightweight Fragment Barriers on Commercial Aircraft**

November 1999

Final Report

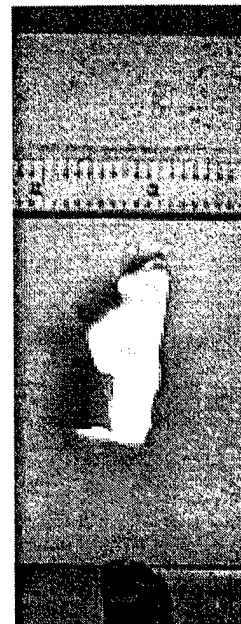
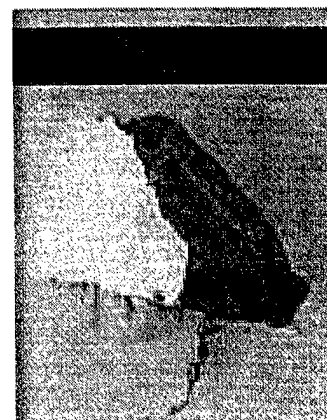
Impact End View

FS  
Impactor

Side View

Outside View

Hole in  
Fuselage Skin

Inside View

Zylon Glued to Insulation

Incomplete Pene-  
tration of Im pactor

Interior Wall Panel

FIGURE 3. POSTTEST PHOTOS FROM TEST 39  
(25-g (0.555 lb) blunt-edged fragment simulator (FS) at 192 m/s (631 f/s)  
1-ply Zylon 35 x 35 fragment barrier glued to insulation.)

Test 38 indicated a baseline energy of 253 J (187 ft-lb) for the 25-g (0.05-lb) fragment. One layer of Zylon fabric glued around the edges to the insulation package (Test 39) increased the absorbed energy to 461 J (340 ft-lb), and two layers (Test 43) absorbed 763 J (563 ft-lb). Thus, one or two layers of Zylon fabric increased the ballistic resistance of the fuselage wall by 80% to 200% while adding only 0.016 to 0.032 g/cm<sup>2</sup> (0.033 to 0.066 lb/ft<sup>2</sup>) to the weight of the fuselage wall. A test with a single layer of Spectra fabric (Test 44) showed a 38% smaller increase in energy absorption. The only test with Kevlar fabric (Test 45) involved significant impactor yaw (about 30°) and, therefore, the measured energy absorption cannot be compared.

Figures 3 and 4 show photographs of the fragment, fuselage skin, and IWP for Test 39 with the small fragment and Test 50 with the fan blade fragment. In these two tests, the fragment was unable to completely perforate the fabric layers. The fabric-cloaked fragment broke through the IWP, but was arrested there. This fragment "capture" mechanism has important implications in designing lightweight barriers, as discussed below.
